**INTERLAKEN TOWN, UTAH**  
**MUNICIPAL ELECTION RESOLUTION**

RESOLUTION NO. 2019-10-14

# Analysis and Recommendations for Street Network

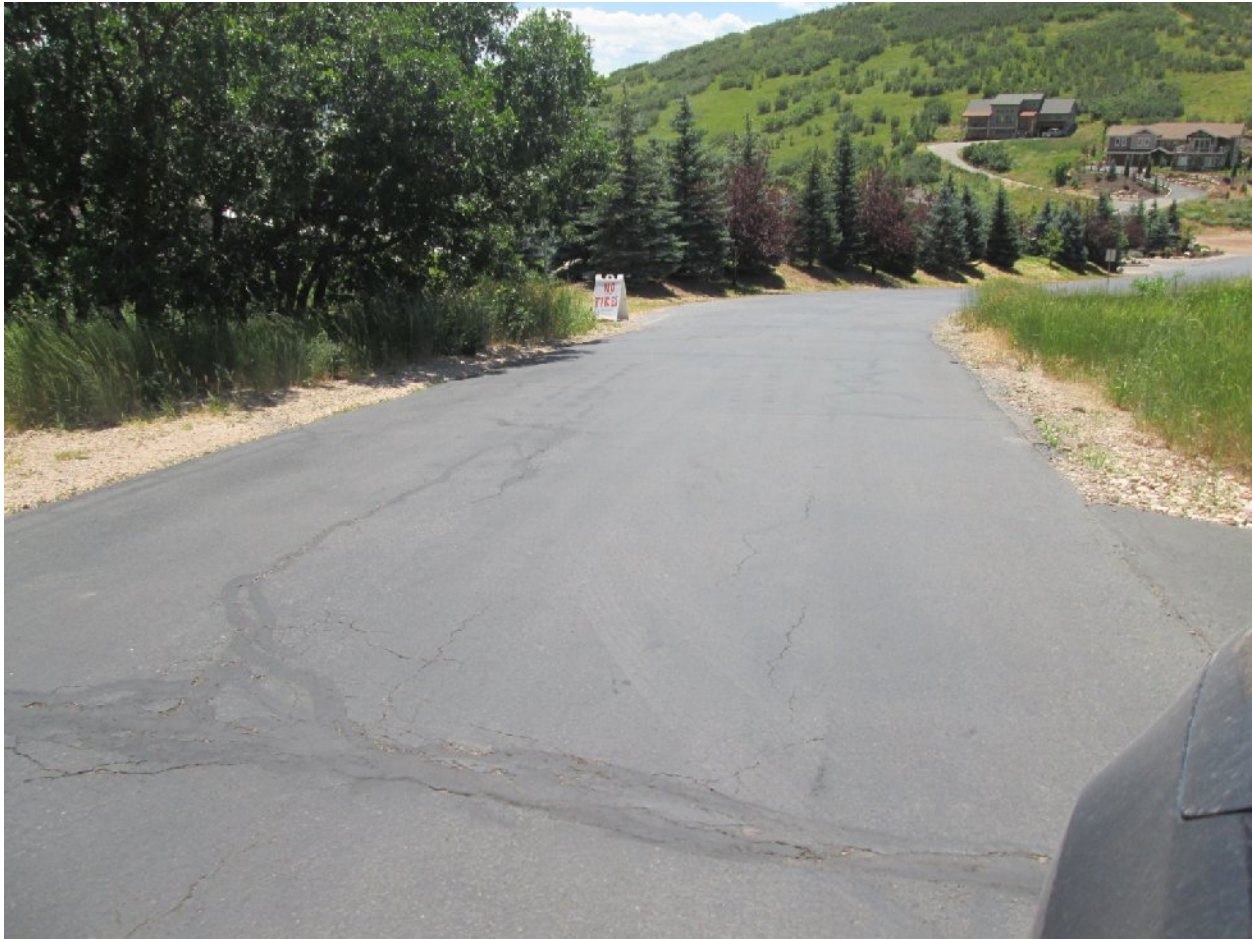
**Photo 1. Fair Condition – Interlaken Dr from Interlaken Dr to Edelweiss Ln (RSL = 8 years)**

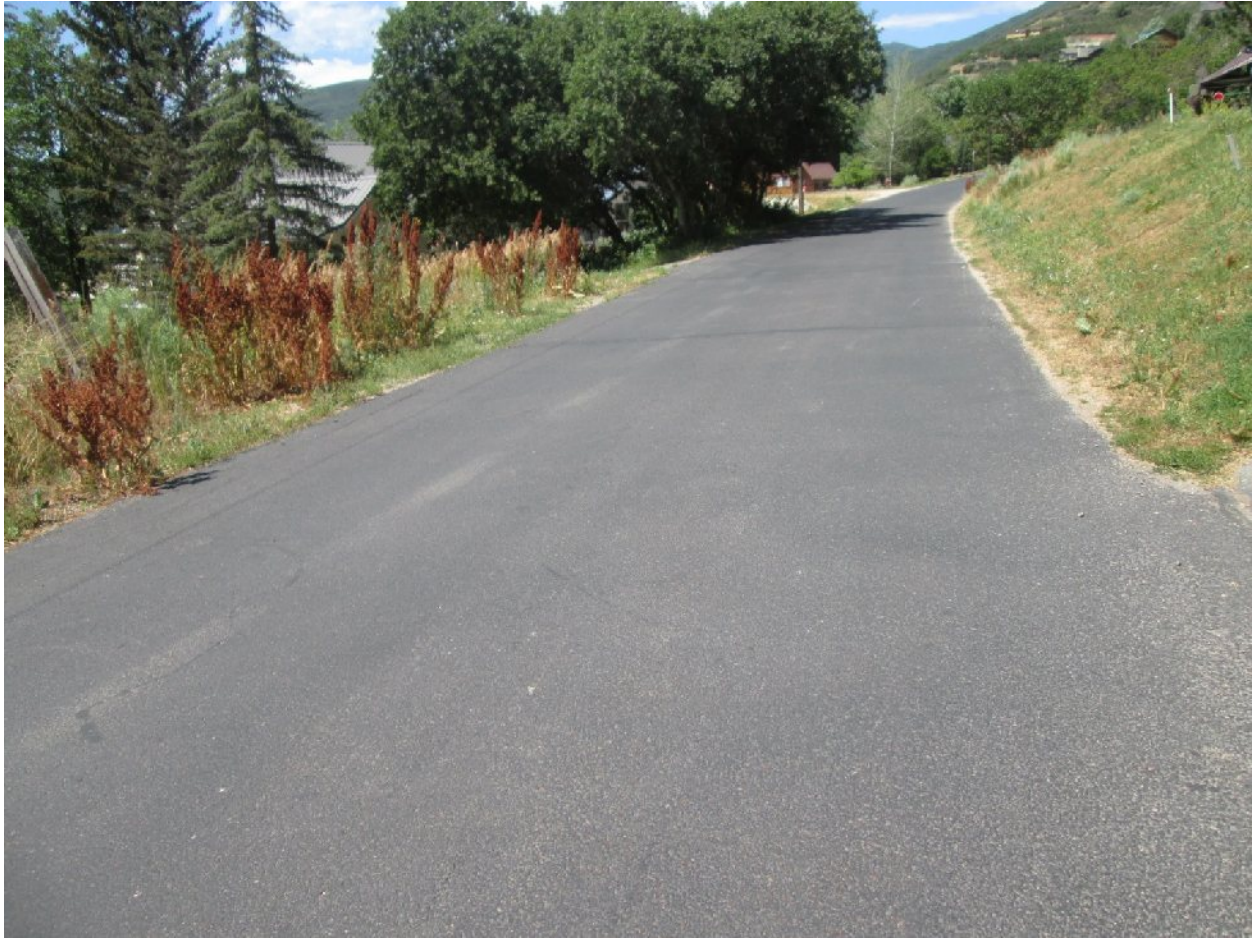
**Photo 2. Good Condition – Interlaken Dr from Interlaken Dr to Luzern Rd (RSL = 10 years)**

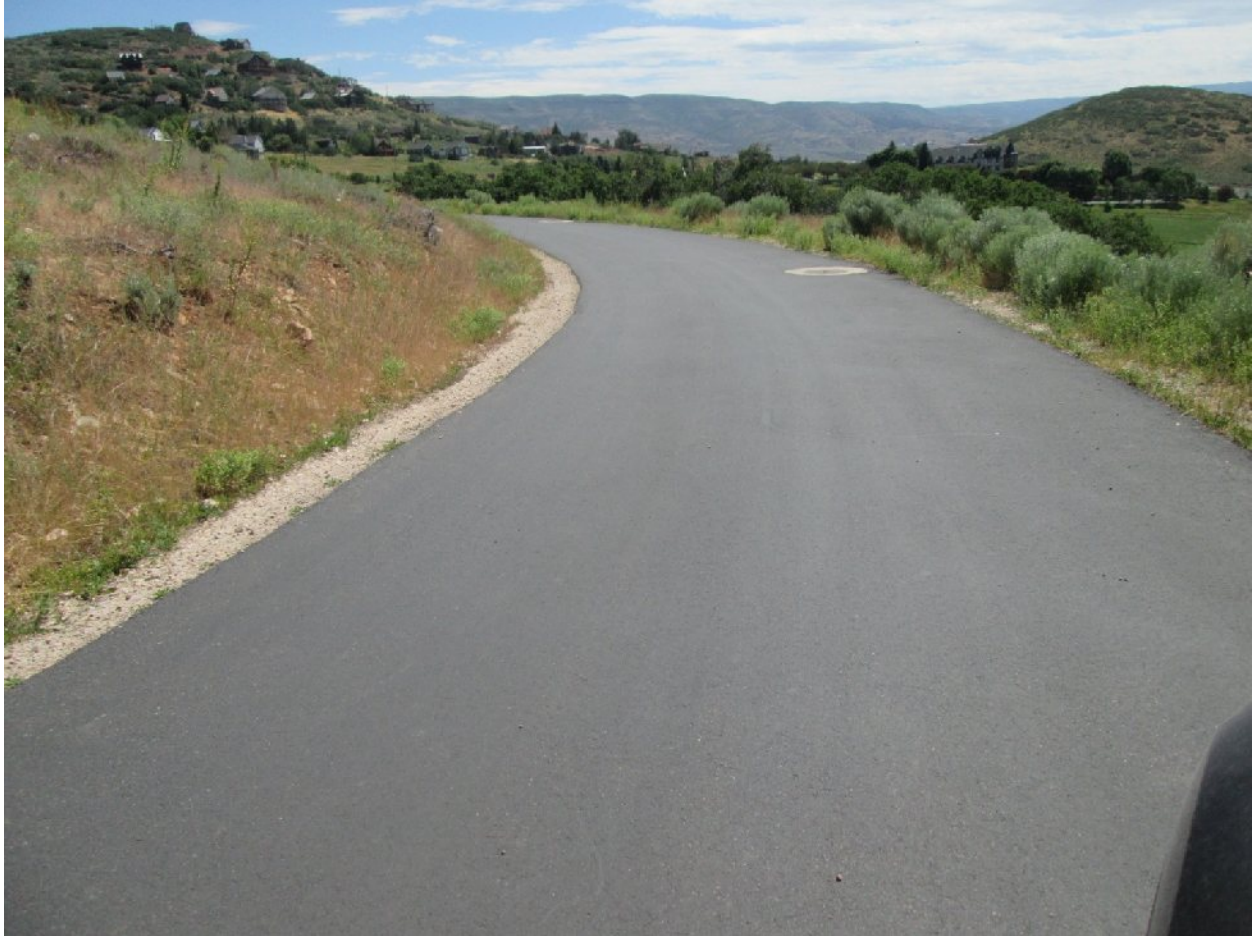
**Photo 3. Very Good Condition – Luzern Rd from Luzern Rd to Luzern Rd (RSL = 14 years)**
